Lake Ōkātaina

INFOSHEET 3, DECEMBER 2017

This information sheet has been prepared for Te Arawa whānau to summarise information about:

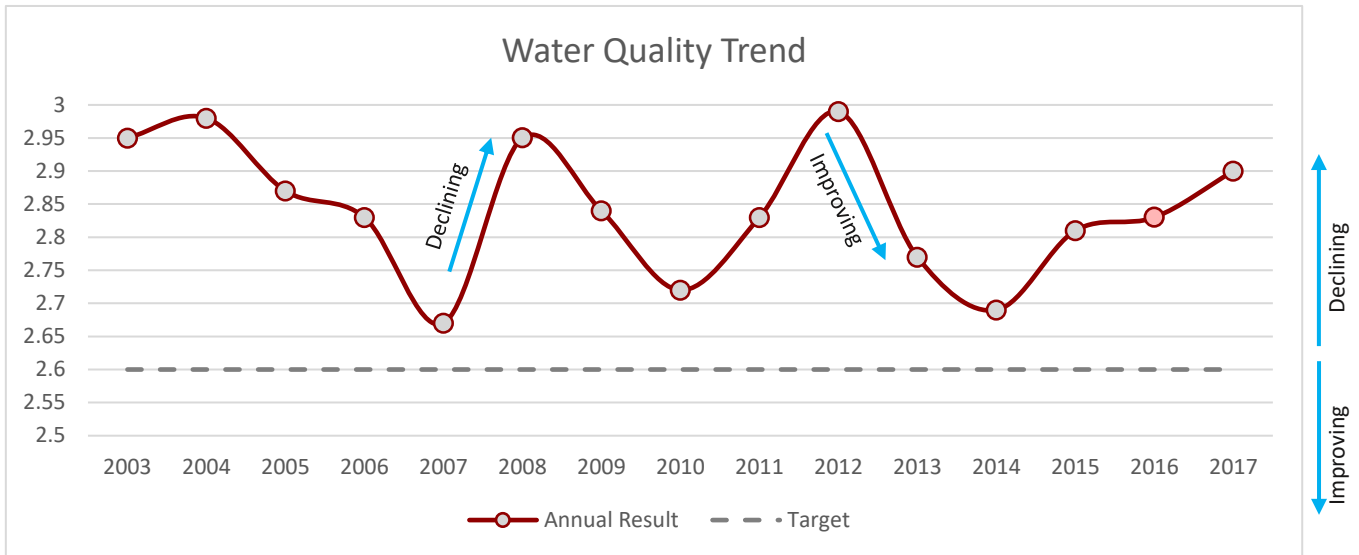
Water quality within Lake Ōkātaina has fluctuated over the last 14 years. It has largely been stable but has yet to reach its target TLI.
